## Facing the Challenges of THT Inspection

### Practical Examples of THT Solder Defects detected by SpectorBOX:

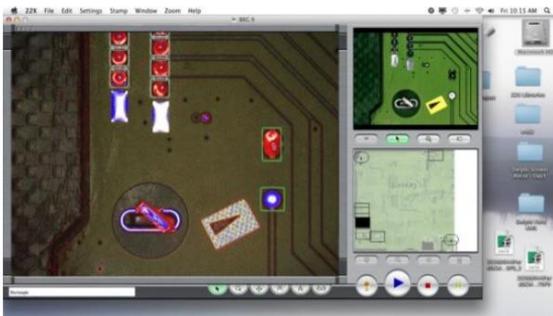
Figure 1: No pin available, solder available: (Top Camera)

Example Problem 1: Mounting problem: No pin available, solder available
